# Willatook Wind Farm, Willatook, Victoria: Historical Heritage Impact Assessment

Willatook Wind Farm Pty Ltd

24 March 2022

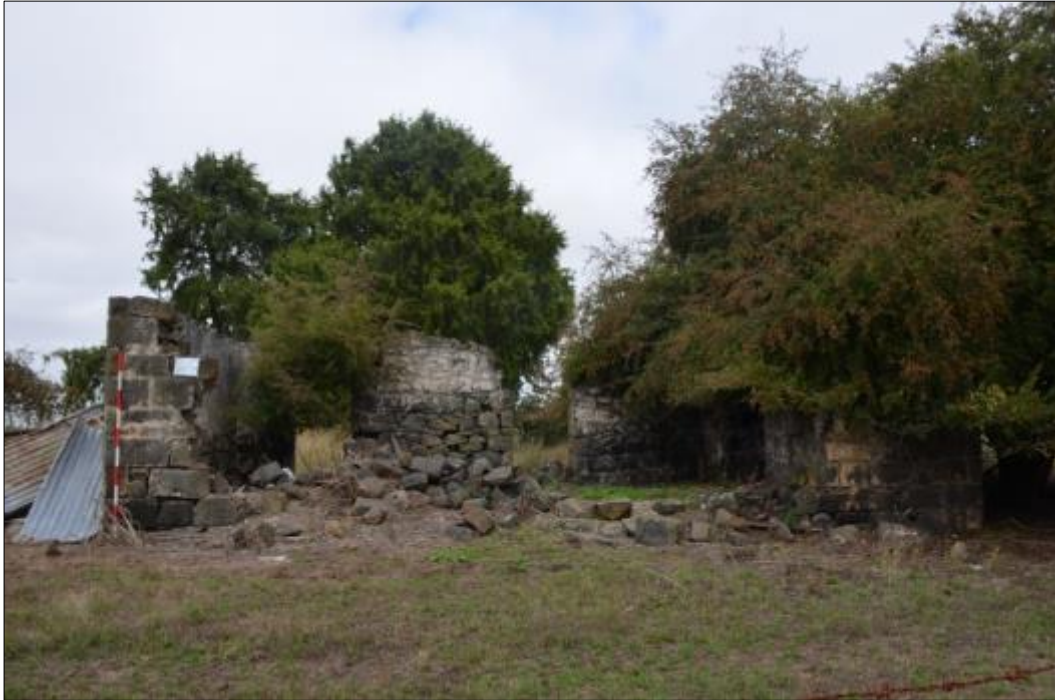
The adjacent bluestone kitchen building is in a ruinous state. It includes a bread oven and evidence of two rooms, indicating a past residential use. Plate 4, a photo taken in 1968 and Plate 5 shows the deterioration of the property since that time.

**Plate 6:** Kitchen site at Dunmore associated with original 1850s estate of Macknight. View South. Photo. A. Wilkinson

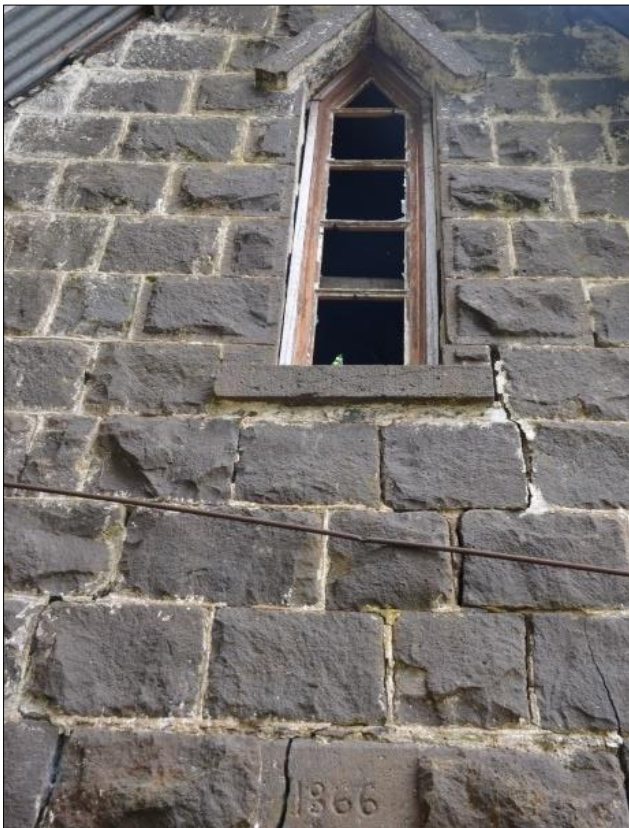
**Plate 13:** Detail of highlight window and stepped cracking on front of Bath House.  
View North. Photo A. Wilkinson

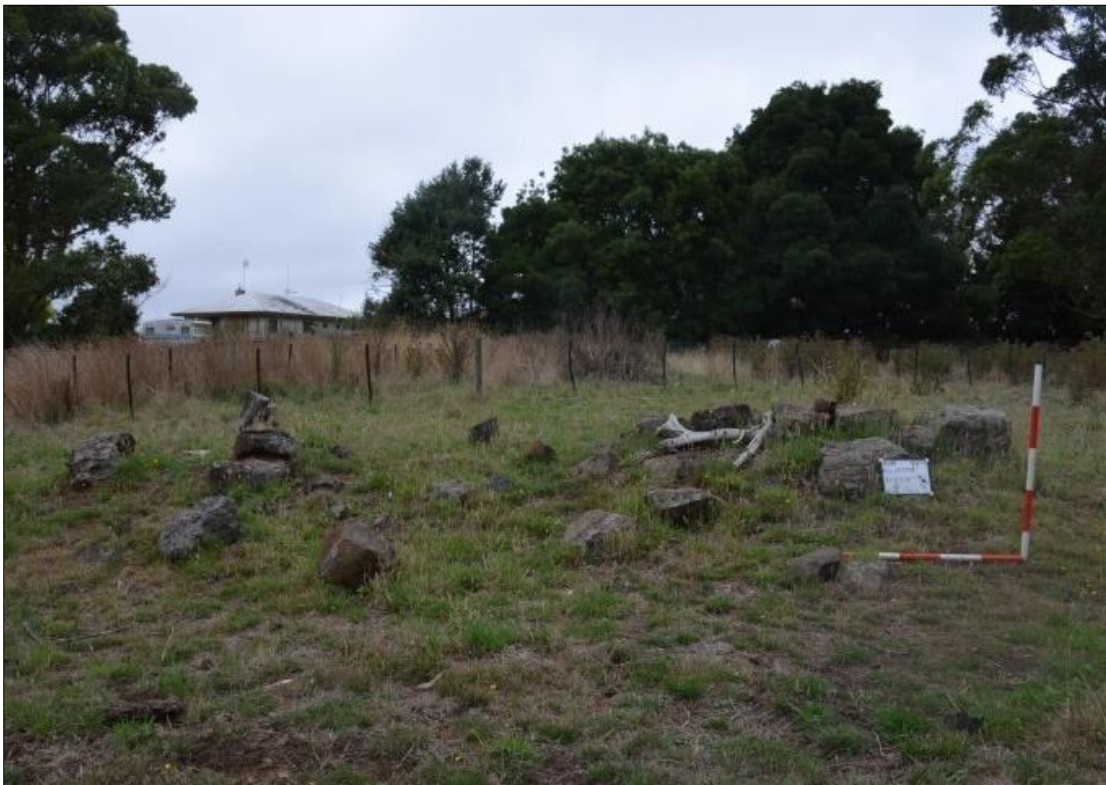
**Condition:** A bluestone and brick structure has been demolished and stone pushed into two main piles, one approximately 10 m x 5 m with brick and dressed bluestone on the surface; the second is approximately 5 x 5 m and is comprised of bluestone rubble. A 1942 ordinance topographic map marks the site as 'Ruin' so it must have been demolished some years prior. The mounds are on otherwise flat or levelled sections of the property and the mound containing the bricks is likely to be the location of original structure. One metal machinery part was also located on top of the rubble pile, likely from farming machinery.

Plate 17: VHI H7321-0105 (Willatook Ruin), view NE. Photo C. De Leiu

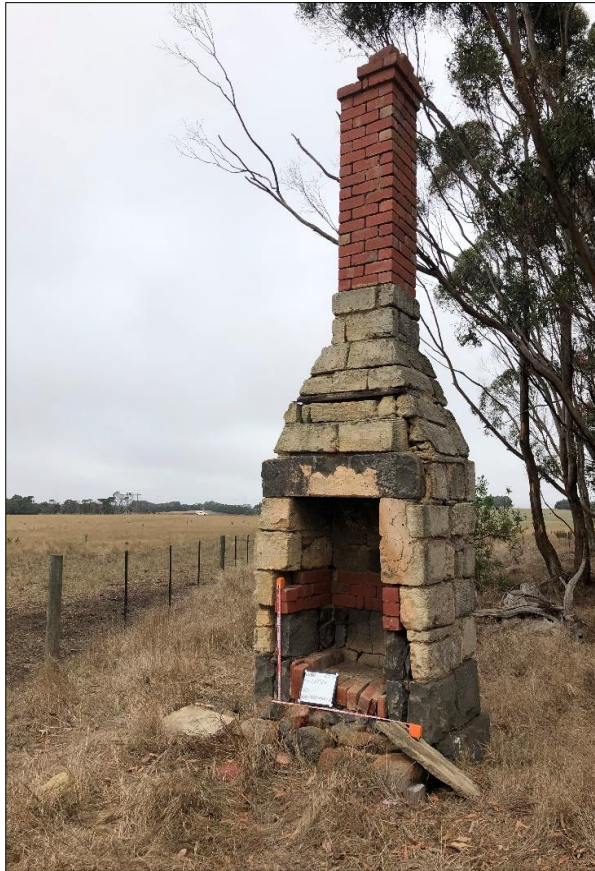
**Condition:** The area is not used; it is fenced and has stored farming machinery. Only a bluestone, sandstone and brick fireplace and chimney remain. There are two courses of cut bluestone at the base of the fireplace or hearth which remain in situ, as well as large piece at top of hearth area. Above the fireplace there are ten courses of dressed sandstone blocks on top of which sits a red brick chimney.

Some bricks inside hearth area show evidence of burning. These could have been added later to replace sandstone blocks that may have been robbed out or have been damaged or fallen out and have been mortared in between bluestone and sandstone courses. The chimney is mostly complete and in fair to good condition.

Brick chimney has approximately 20 courses, with some bricks missing from the very top. Stepped cracking and movement where mortar has eroded in between sandstone blocks is evident, with some rubble in front of hearth, indicating that the structure is unstable.

**Plate 19:** VHI H7321-0104 (Woolsthorpe-Heywood Road Hut 1) chimney view NE. Photo C. De Leuen

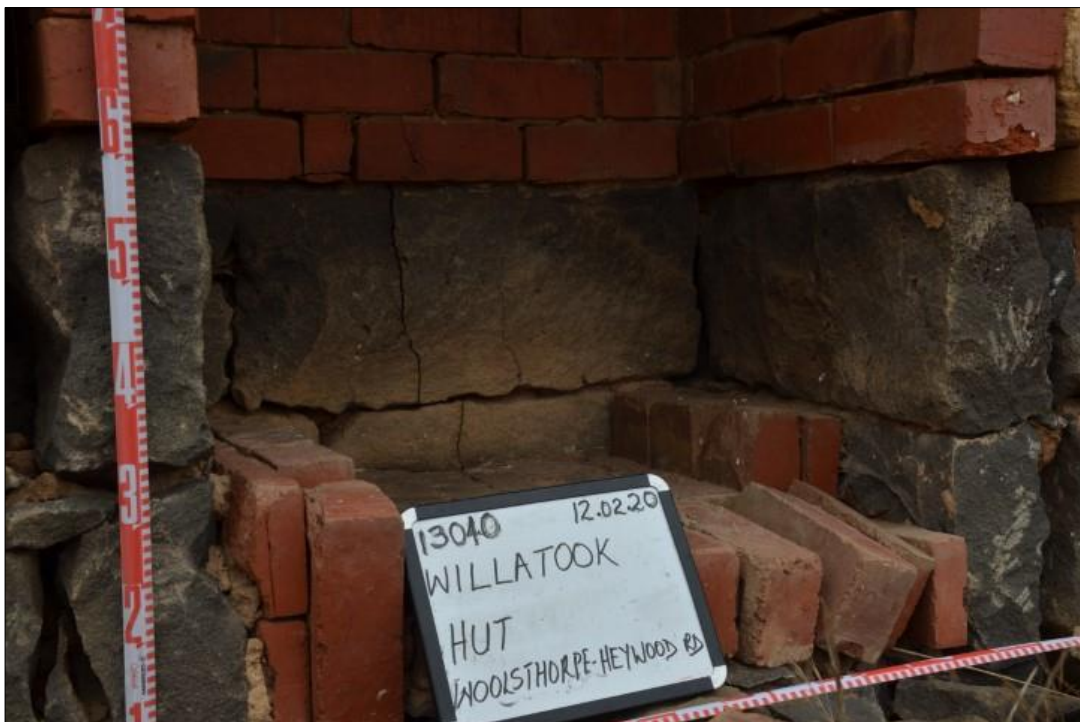
**Plate 22:** VHI H7321-0104 (Woolsthorpe-Heywood Road Hut 1). Detail of bricks inside chimney structure indicating replacement and/or reuse. Photo A. Wilkinson

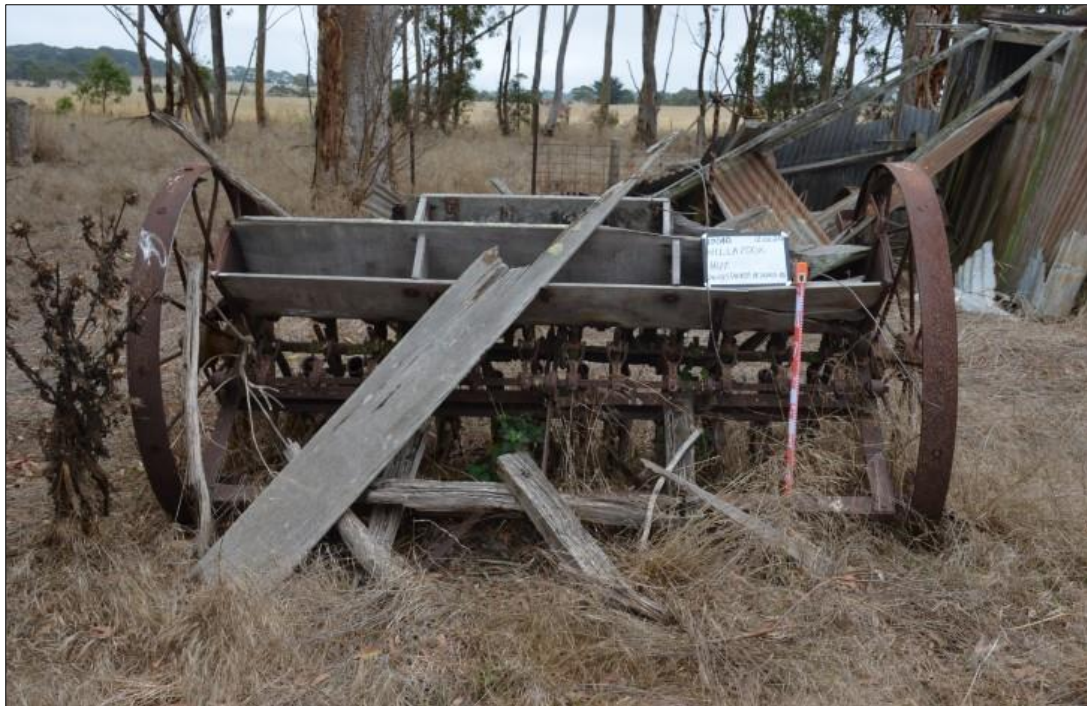
that is also in a poor condition. Approximately 5 m west of this shed is farming machinery (uncovered) with the makers mark 'Made in Australia' visible. The farm machinery is highly corroded, but in an overall fair condition.

**Plate 23:** Farming machinery at VHI H7321-0104 (Woolsthorpe-Heywood Road Hut 1), view SE. Photo A. Wilkinson

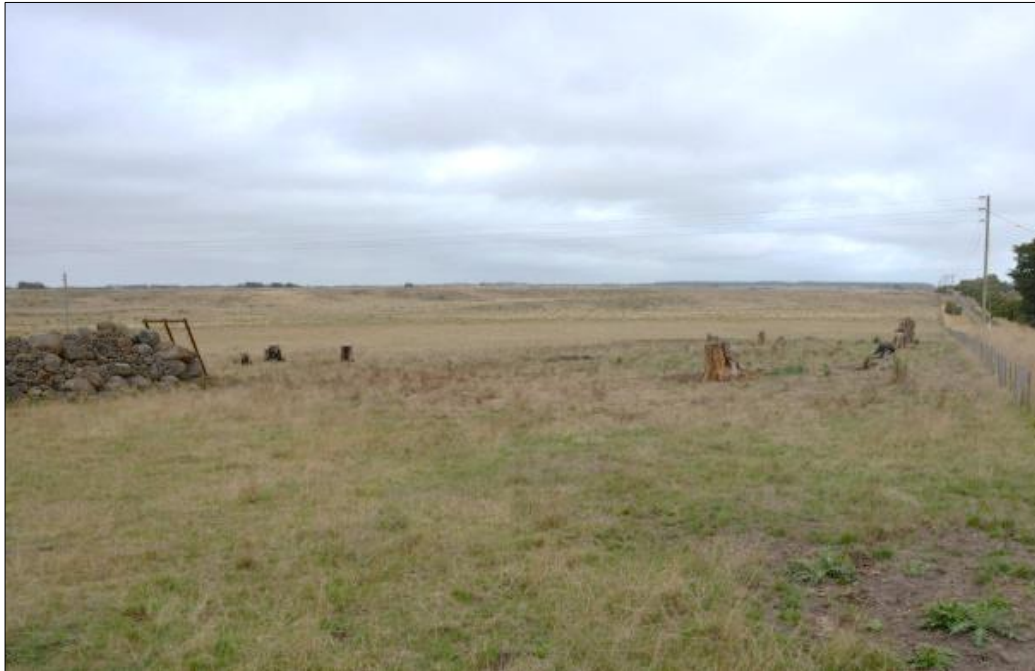
**Condition:** Demolished; unable to be located. The area has been cleared of trees and rock and rubble. Any natural rock and possibly the remains of the hut have been pushed into a pile in the corner of

property. There was no other evidence of a building footprint in the area, however, access was limited due to the presence of electric fencing. Drone photography did not locate any other building footprint in the wider area (plate 26).

**Plate 25:** Likely location of Sandy Camp Hut. Rubble pile may contain some remains from a camp hut.  
View W. Photo A. Wilkinson

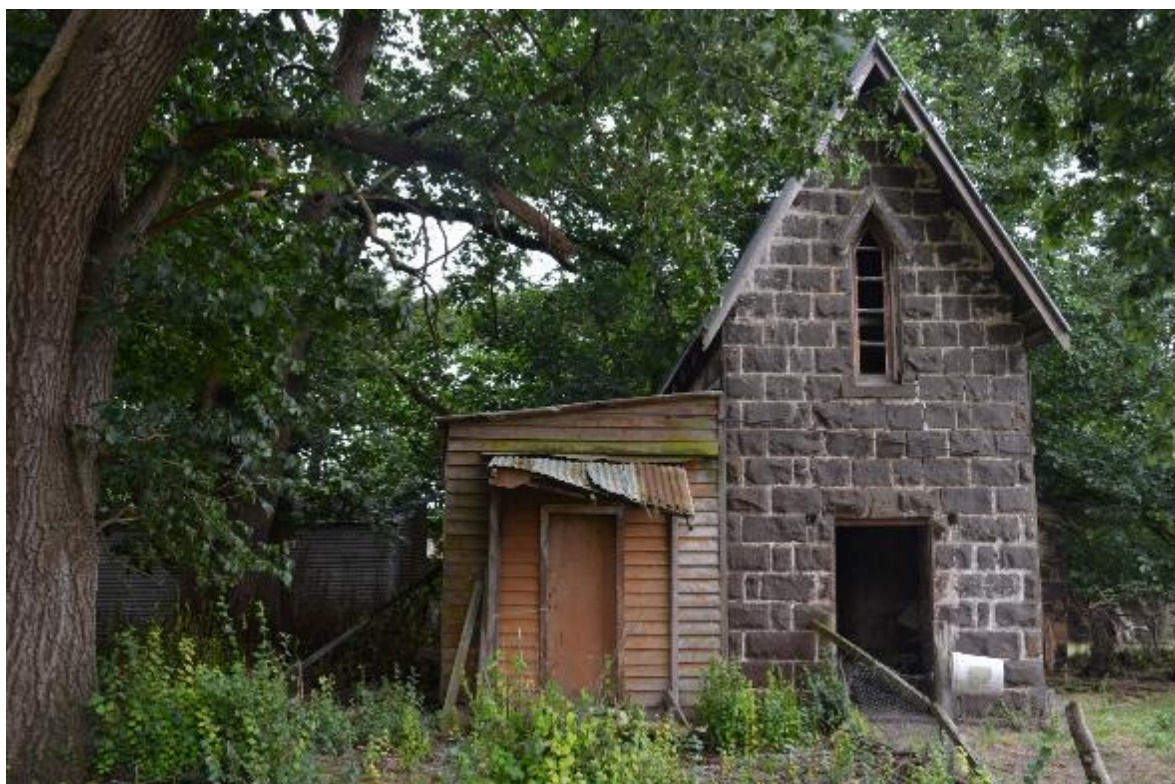
**Plate 1:** Dunmore Turkish Bath House, front, showing portal and highlight window and later timber skillion extension built on western side, view facing north Photo: C. De Leiven

The later 20<sup>th</sup> century additions of a weatherboard skillion on the left side and to the rear (north) section remain but are collapsing and hazardous (these are first shown on a 1968 image by J Collins SLV see Plate 2)

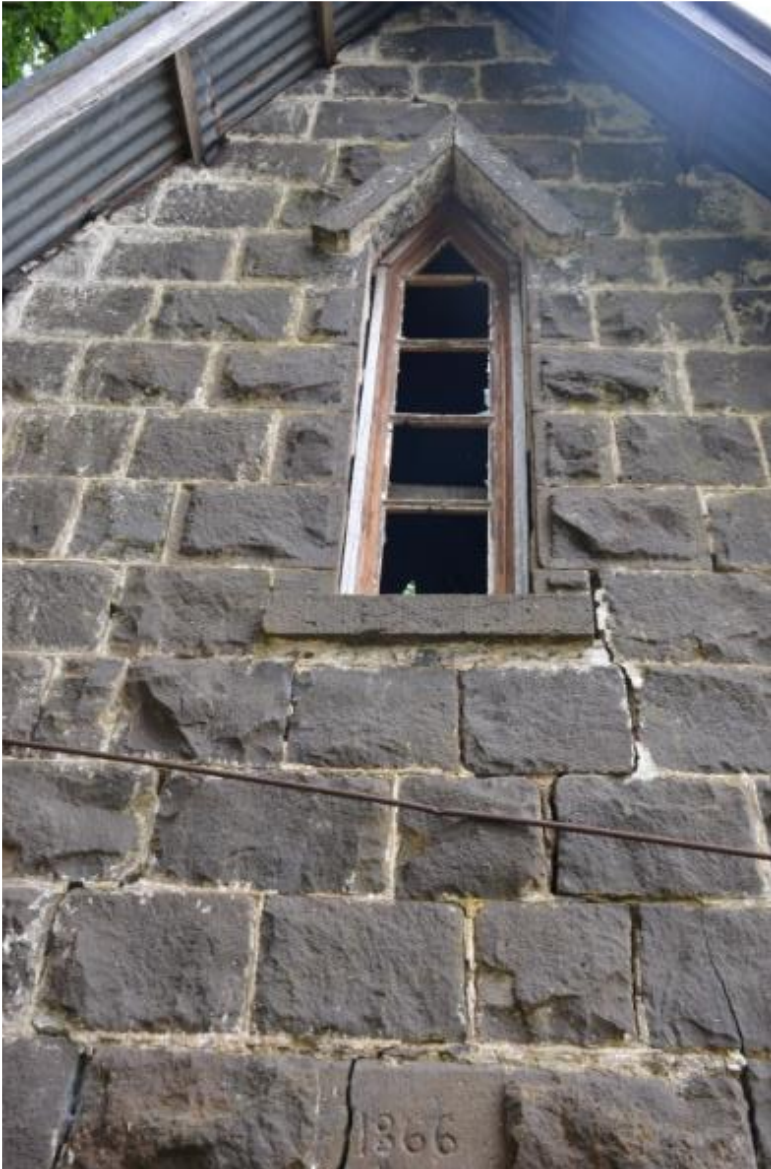
**Plate 11:** Detail of highlight window and stepped cracking on front of Bath House. View North. Photo A. Wilkinson

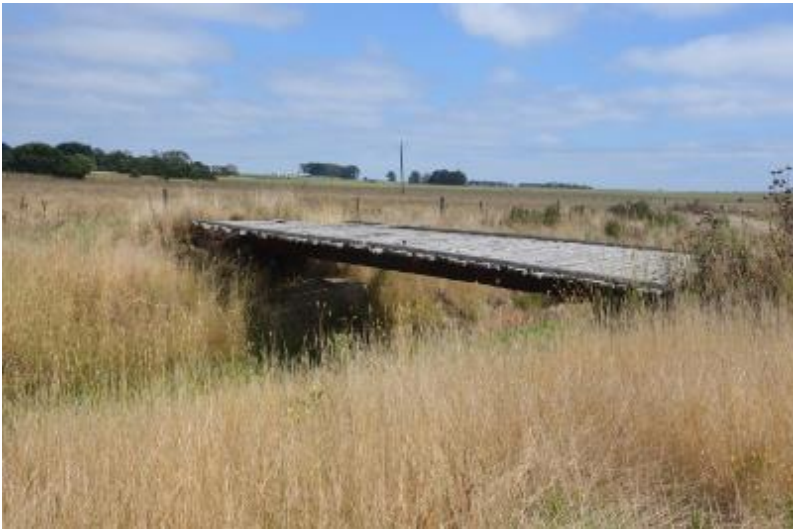
**Condition:** Poor, abandoned/not in use. The inspection of the timber and iron bridge was limited due to dense ground vegetation along the eastern bank of the Shaw River and general state of disrepair of the bridge itself. The bridge still connects either side of the River but is disused and in a state of deterioration. The timber running deck is in overall poor condition with some collapsing. The supports were unable to be inspected in detail but appear to be constructed of iron which is corroding. There appears to be decay also under flashing and at the ends of the deck system at abutments, with particularly on contact areas with the piers. The piers appear to be in fair condition, made of concrete and some bricks visible around reeds. There appear to be serious internal deterioration that may be manifest at joints and connections.

**Plate 15:** Paradise Bridge crossing Shaw River approx. 50 m north of Woolsthorpe-Heyward Road. Photo C. De Leiuén

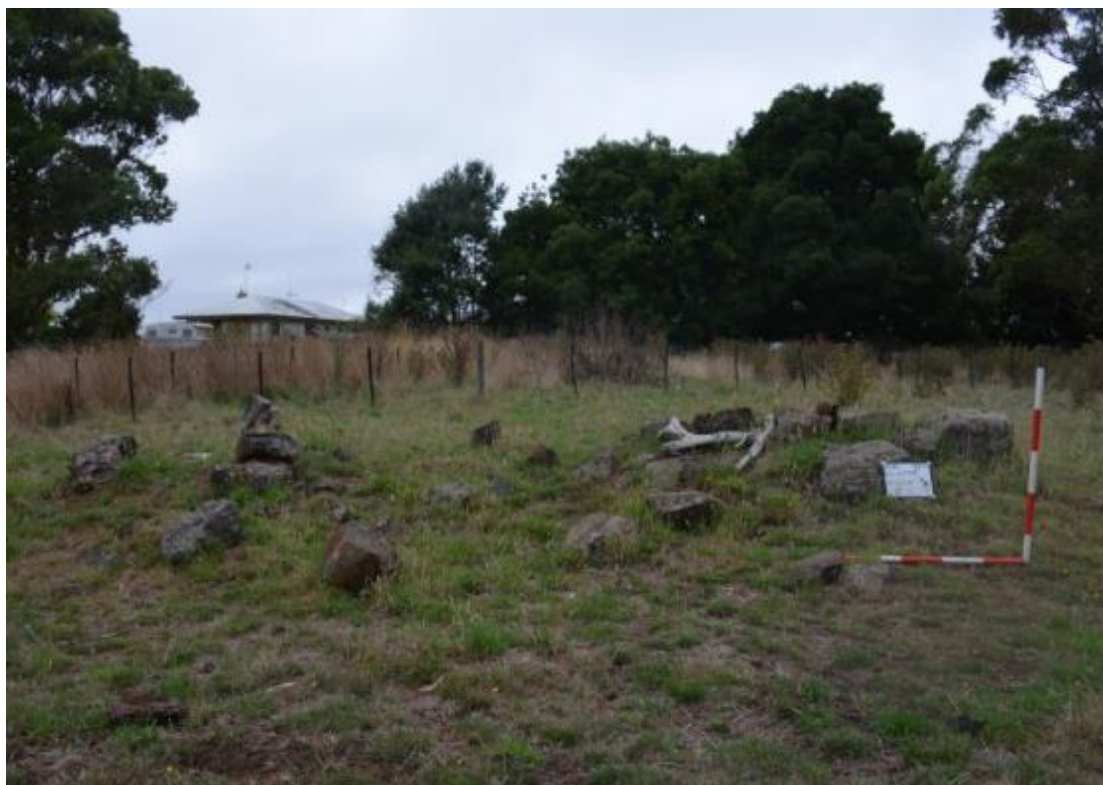
**Condition:** Site has been demolished/ not in use. A bluestone and brick structure has been demolished and stone pushed into two main piles, one approx. 10 m x 5 m with brick and cut bluestone on surface, the second approx. 5 x 5 m and is bluestone rubble. A 1942 ordinance marks the site as 'ruin' so likely to have been demolished some years prior. Mounds are on otherwise flat/levelled section of the property and the mound containing bricks is likely to be in the location of original structure. One metal machinery part also located on top of the rubble pile, likely from farming machinery.

**Plate 17:** Ruin site, view NE. Photo C. De Leuven

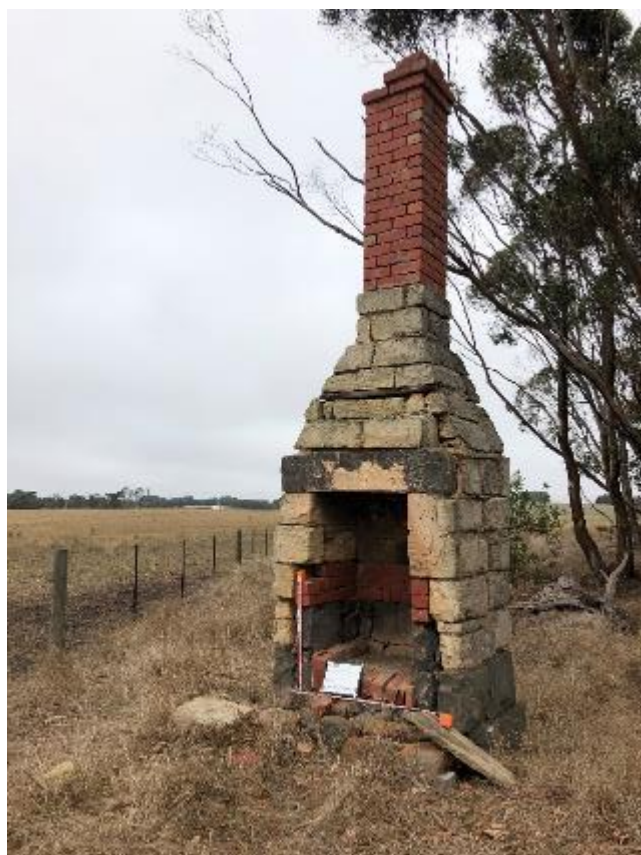
**Plate 19:** Hut 1 site chimney view NE. Photo C. De Leiu

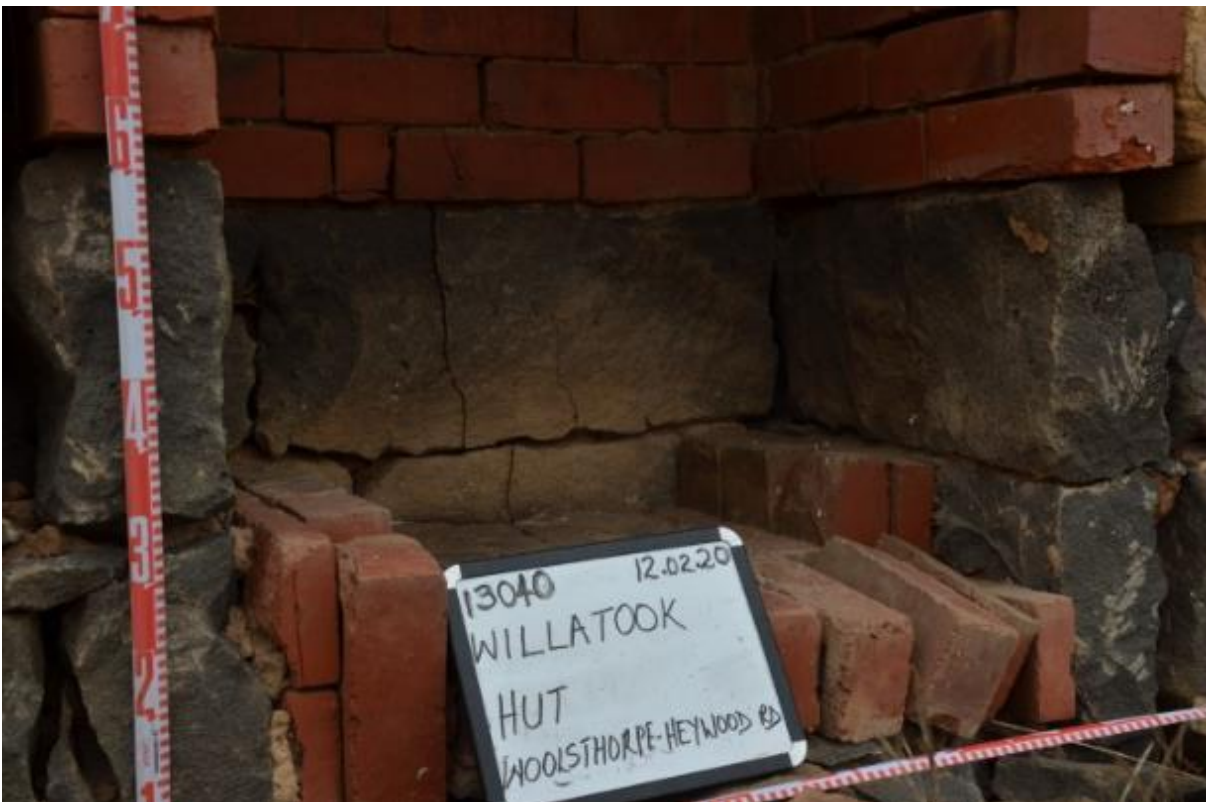
Plate 22: Detail of bricks inside chimney structure indicating replacement and/or reuse. Photo A. Wilkinson

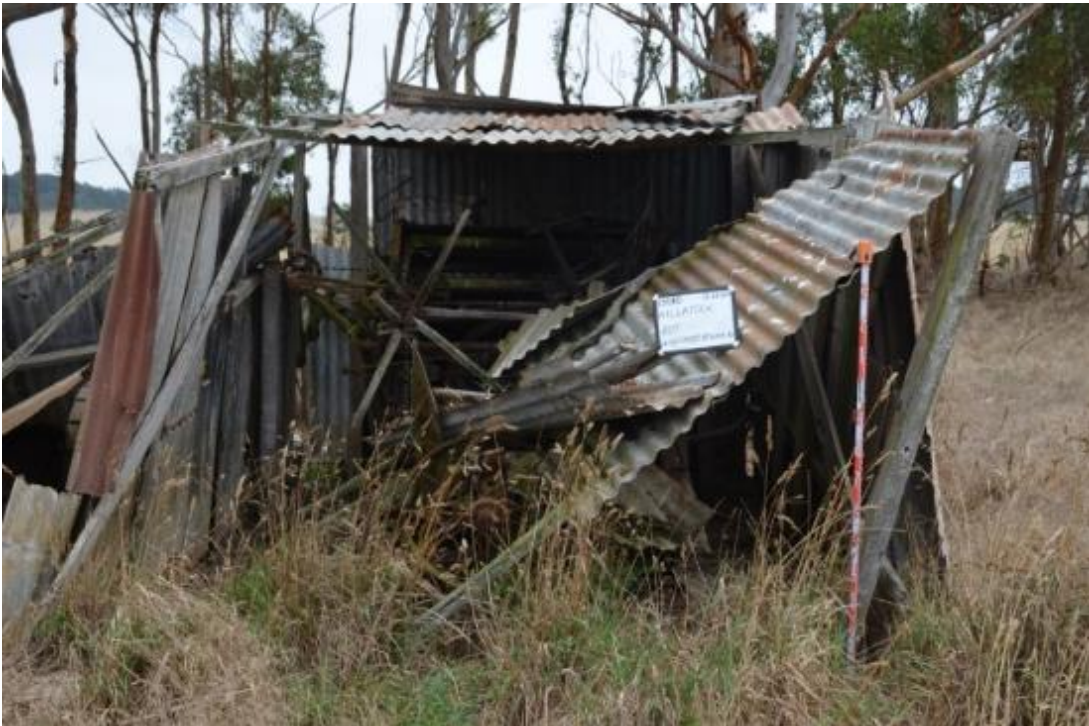
25 m north west is a corrugated iron shed constructed with timber beams. This structure is in very poor condition, and is collapsing, with half of the roof coming away from beams and leaning towards the ground. Some corrosion also present. The shed contains farming machinery that is also in a poor condition. About 5 m west of this shed is farming machinery (uncovered) with the makers mark 'Made in Australia' visible. Highly corroded, but in an overall fair condition.

Plate 23: Shed remains at Hut 1 site. View SE. Photo A. Wilkinson

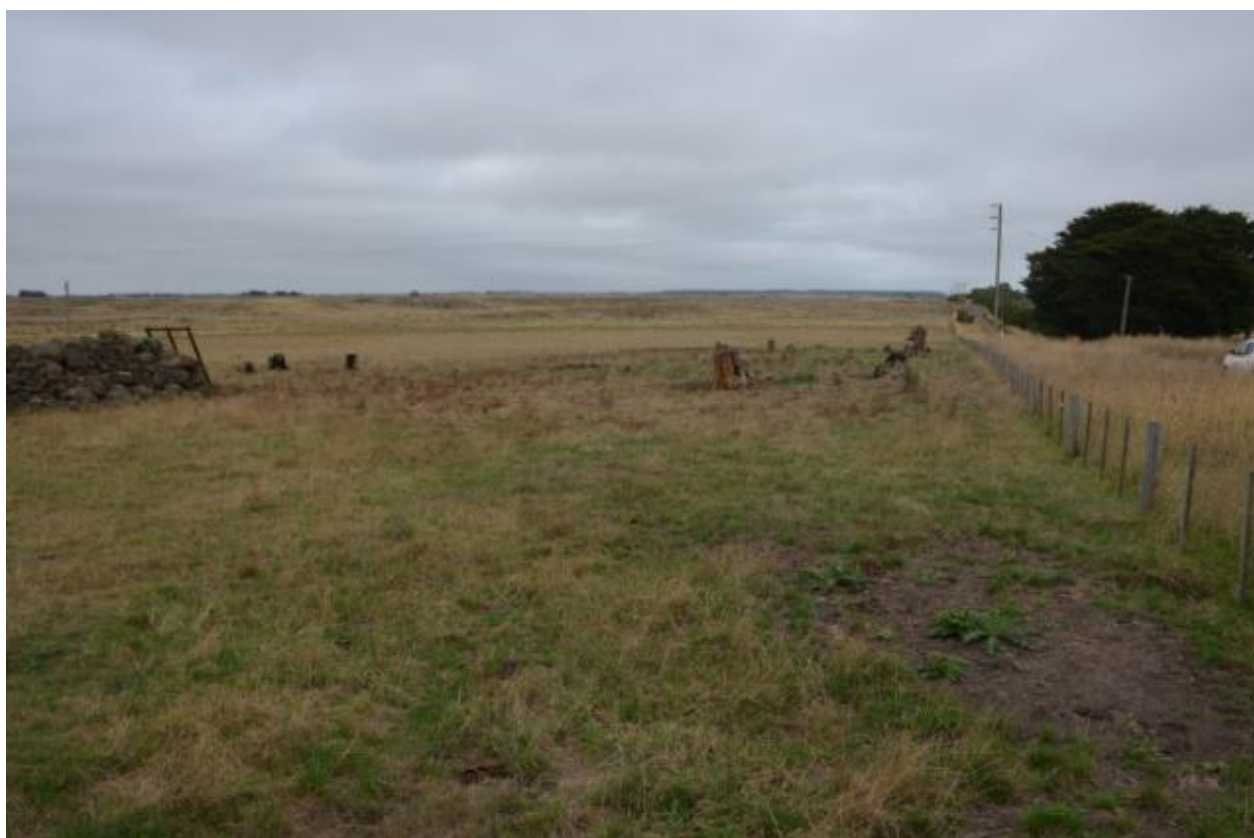
Condition: demolished or unable to be located. Area has been cleared of trees and rock and rubble. Any natural rock and possibly the remains of the hut have been pushed into pile in corner of property. No other evidence of building footprint in the area, however access limited due to electric fencing. Drone photography did not locate any other building footprint in the wider area. No site remaining in situ.

**Plate 26: Likely location of Sandy Camp Hut. Rubble pile may contain some remains from a camp hut. View W.  
Photo A. Wilkinson**

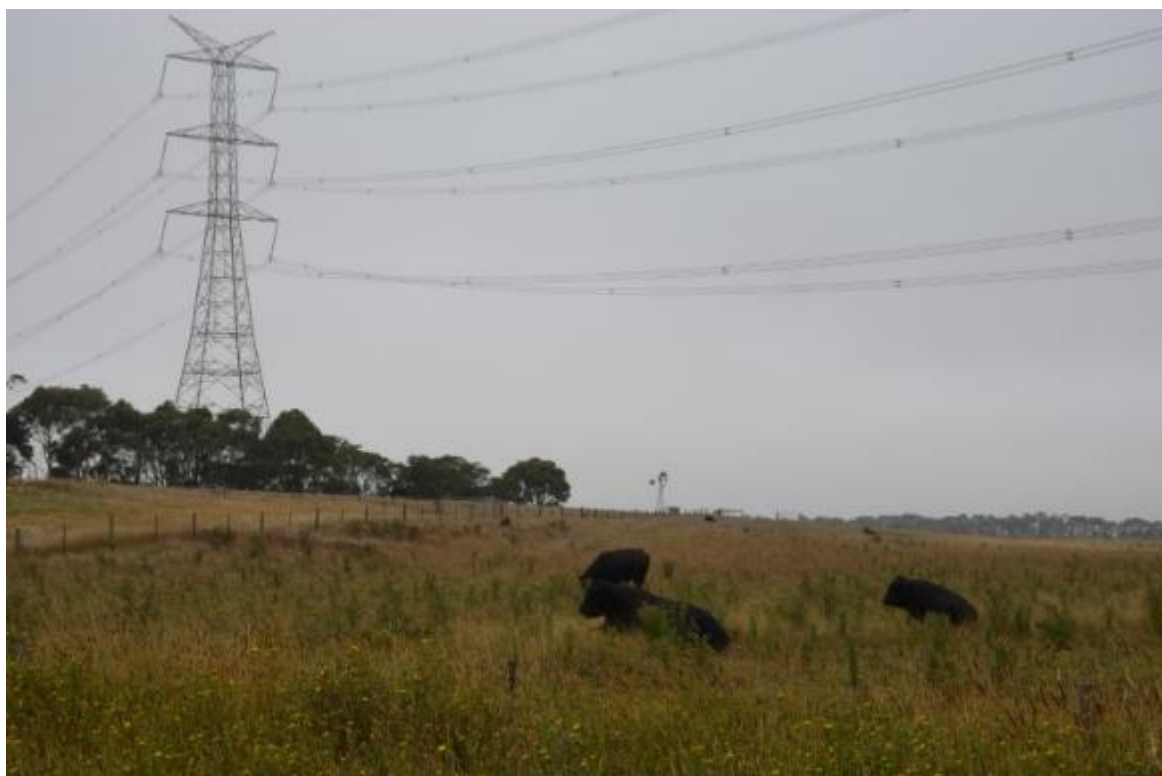
Condition: The pumphouse was unable to be located or accessed, thus its condition (if present) was unable to be assessed. There was a windmill in the approximate location of the pumphouse on the 1942 map, which was visible in the distance from the roadside. The pump house could relate to this windmill which seems to be in low lying area subject to flooding.

**Plate 27: View east showing windmill in distance. May be site of historic pump house. Photo. A. Wilkinson**
